HYDROLEC DIS-ASSEMBLY

This page discusses the dis-assembly of the Hydrolec Unit. Please see the Hydrdrolec rebuild page for the re-assembly process. The original page became to big with 42 photos and text!! It took forever to load.

The Freshwater hydraulic turbo-generating set was made by the Hydrolec Division of Leroy Somers, in Granby Quebec, in the mid 1980s. Hydrolec went out of business in 1989. One has to be inventive to obtain spare/replacement parts.

The unit is a Model H9H-18 with four, automatically adjusted, cast aluminum blades. The total assembly, minus the butterfly valve, weighs 3550 pounds. At a nominal head of 18 feet, the unit produces 84 kilowatts. It spins at 328 rpm and drives a 5.6:1 ratio, planetary, speed increaser that in turn, drives an 84 kilowatt, 1200 rpm induction generator. The generator is rated 3 phase, 60 hertz, 150 amps at 480 volts. The generator frame is a 405 T. It has 4 poles and spins at 1835 RPM. The power factor is 0.85. The water is shut off with a 60" butterfly valve.

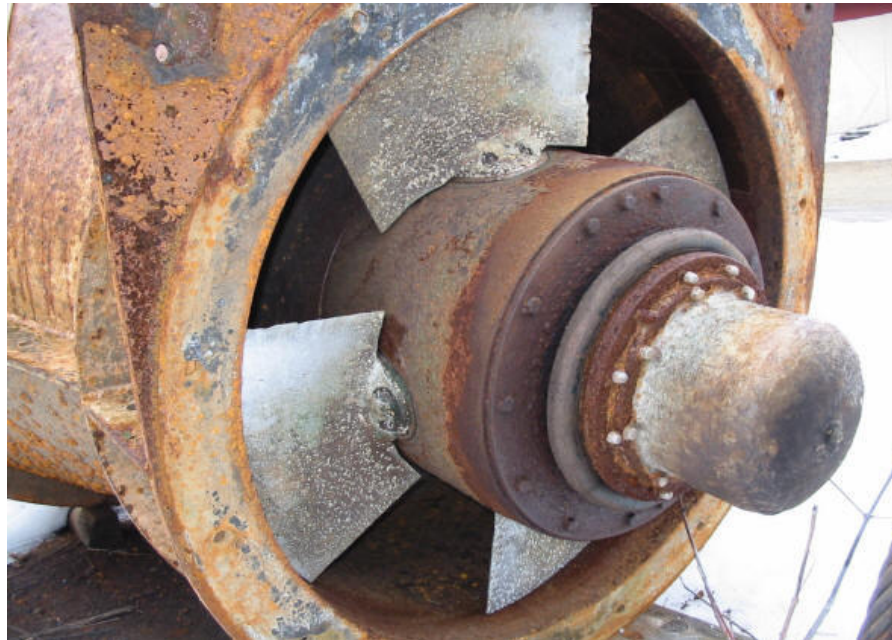
This is the Kaplan hub as we first saw it. Note the black rubber doughnut is the Firestone airbag. The plate and nosecone are attached to the top of the airbag. The bottom of the air bag is attached to the spinning hub. As the internal pressure is increased the aluminum blades are actuated.

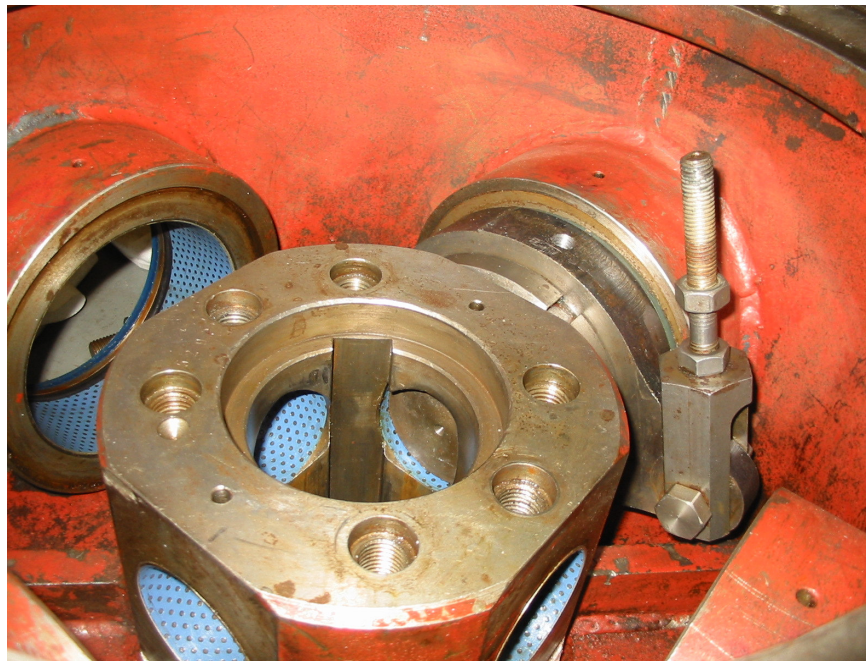
The inside of the hub. Note one blade is assembled and you can see the bell crank and tie rod. Note the Federal Mogul, Glycodur plastic journal bearings. Note the large neoprene o-ring and plastic grit ring.

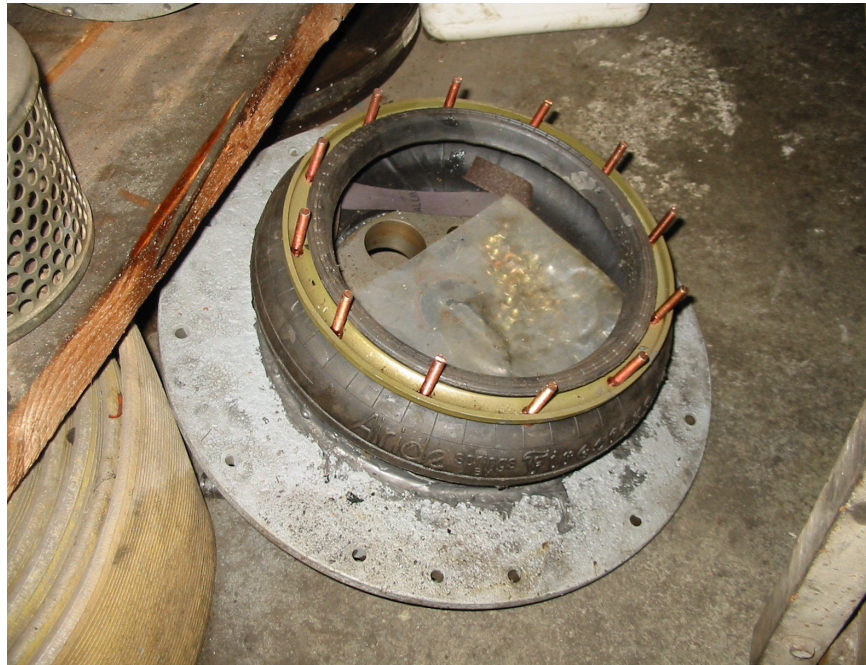
Here is the new Firestone airbag attached to the runner cover. It is an Airide, model 119B. Order number W01-358-7478. At 100 psi its maximum diameter is 17.4 inches. With a three inch assembly height, at 40 psi, it applies 6920 pounds of axial force.

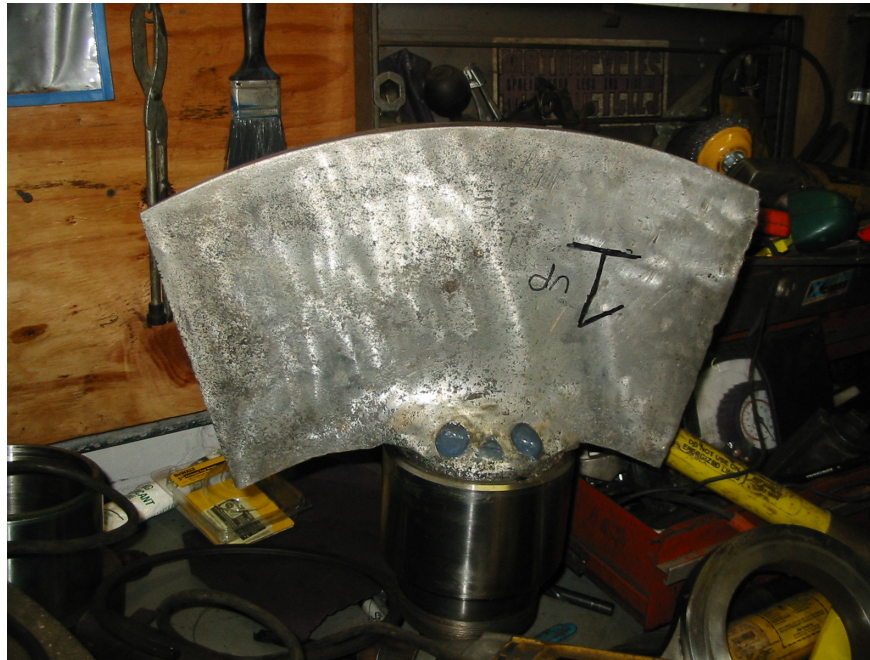
A typical blade. The shiny cylinder on the bottom of the blade is a replaceable wear sleeve that rotates in the Glycodur bearing. The original was chrome plated. The chrome was worn through where the sandy water lodged in the o-ring and abraded the chrome surface. We were going to grind the chrome off, re-chrome the surface and regrind the chrome. We finally purchased a solid bar of stainless steel. The Wizard turned four new sleeves out of the solid bar.

Co-conspirators!!! We needed to remove the old wear sleeve from the blade trunion. It was held on by LockTite. In order to remove it, we needed to heat the assembly up to 500 deg F. While Carol was teaching ballet, Celeste and Will snuck the blade into our kitchen. They put the blade in the electric stove and baked it at 500 deg F. I think they may have told Carol that they were baking brownies!!! The high temperature broke the bond and we were able to remove the sleeve.

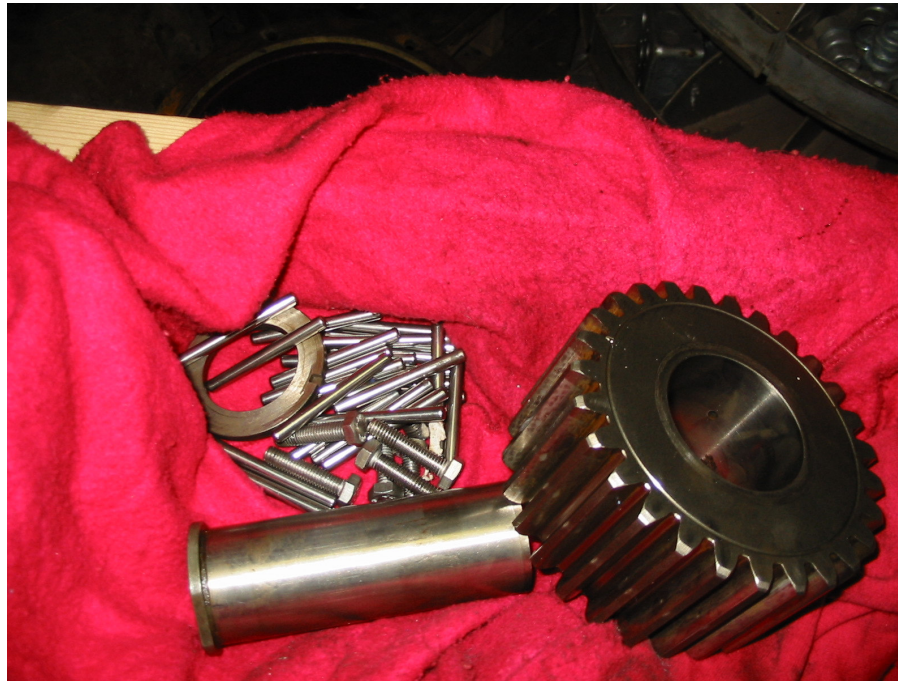
A view of one of the planets, a planet axle, the thrust collar and 25, 6 mm dia. by 60 mm long needle rollers. The rollers on one of the planets were corroded by water of unknown origin.

The Torrington Division of Timken Bearing Company said they could make the new needles. The catch was, we needed to order 3000 needles, at \$3.00 each. We thought \$ 9000.00 for 75 rollers was a little steep. We noticed that Torrington listed the surface hardness and finish at 60 Rockwell and 25 microns. We found hardened dowel pins sold by Fastenal Company. The pins were listed at 72 Rockwell and 30 microns. The 75 pins cost \$28.00. We installed the dowel pins.

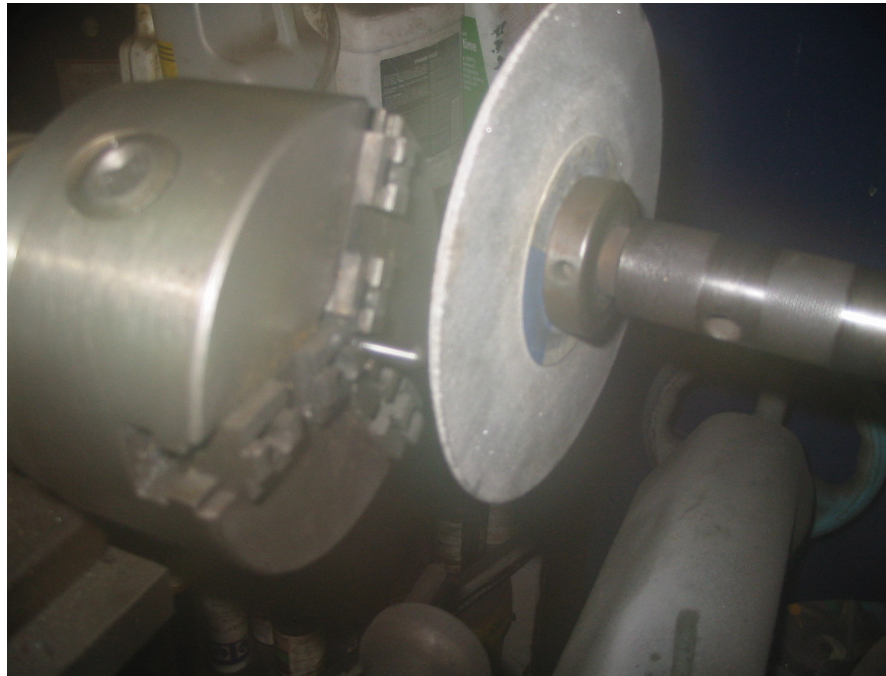
Grinding a replacement needle to the correct length

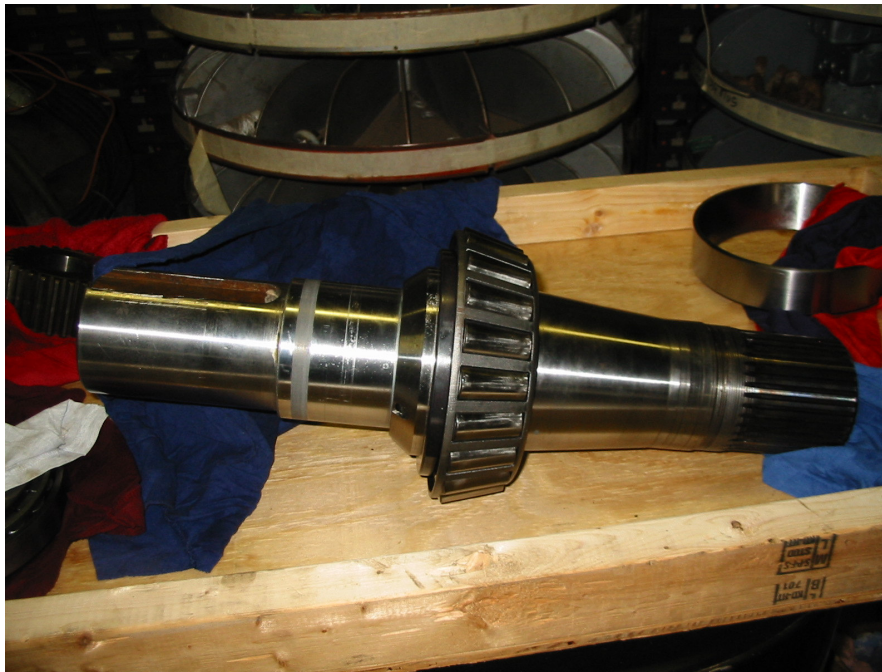
This is the main shaft of the speed increaser. The bearing is new. Note the grey band on the shaft. The shaft was worn at this location where the mechanical oil seal rode. The Wizard cut a dove tailed slot on the shaft. We packed it with Belzona, let it dry overnight and turned it down to the same main shaft diameter. The main bearing is a Consolidated FAG No. 32226. The upper radial bearing is an FAG 30221.

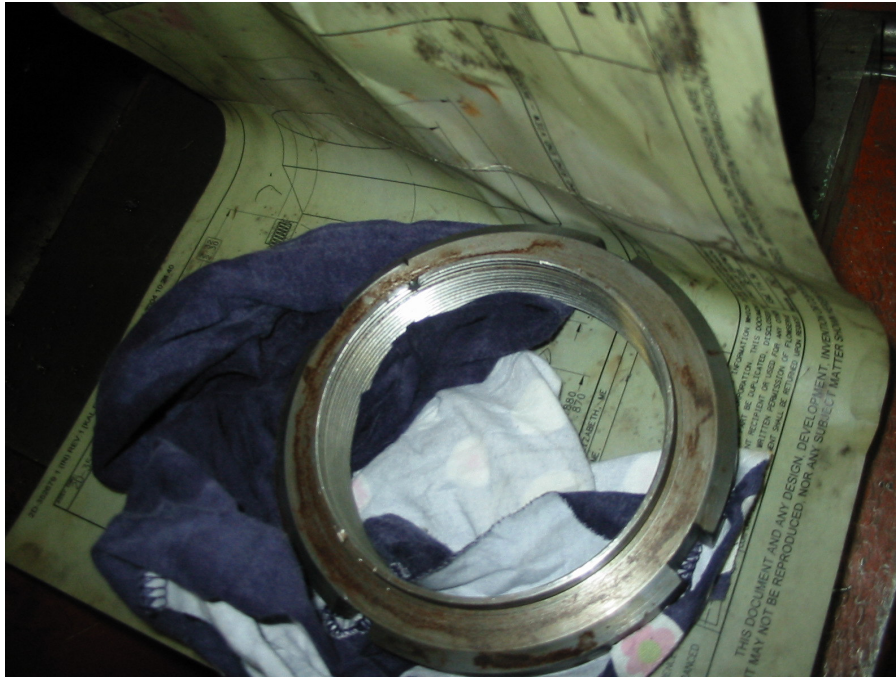
This is a Timken bearing nut. The original was Locktited on. We did not want to damage the shaft by heating it so we cut the nut off. The Wizard made a new nut.

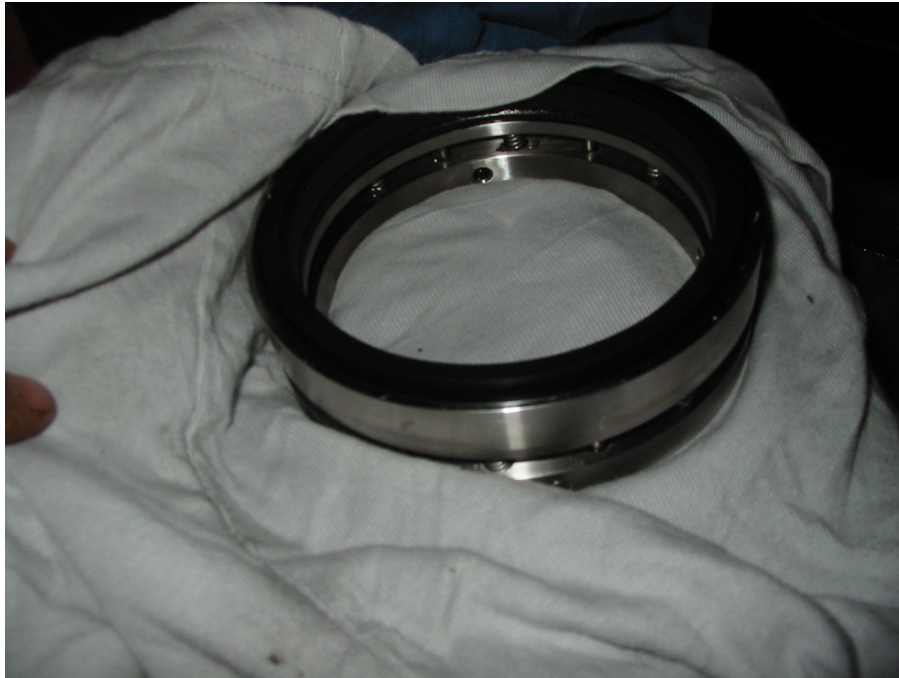
The original oil seal was a Hydrolec OEM. It is a special low profile seal. Andy Lemaider has several of these units running on the Royal River in Falmouth, Maine. He steered us to the FLOWSERVE Company, Fluid Sealing Company of Kalamazoo, MI who supplied us with a replacement seal shown here. It is a single inside BRO, B/M No. 354352, shaft size: 110 mm, seal size: 4.331, assembly drawing 2D-352679. Note the row of tiny compression springs that press this rotating component against the stationary carbon element (not shown).

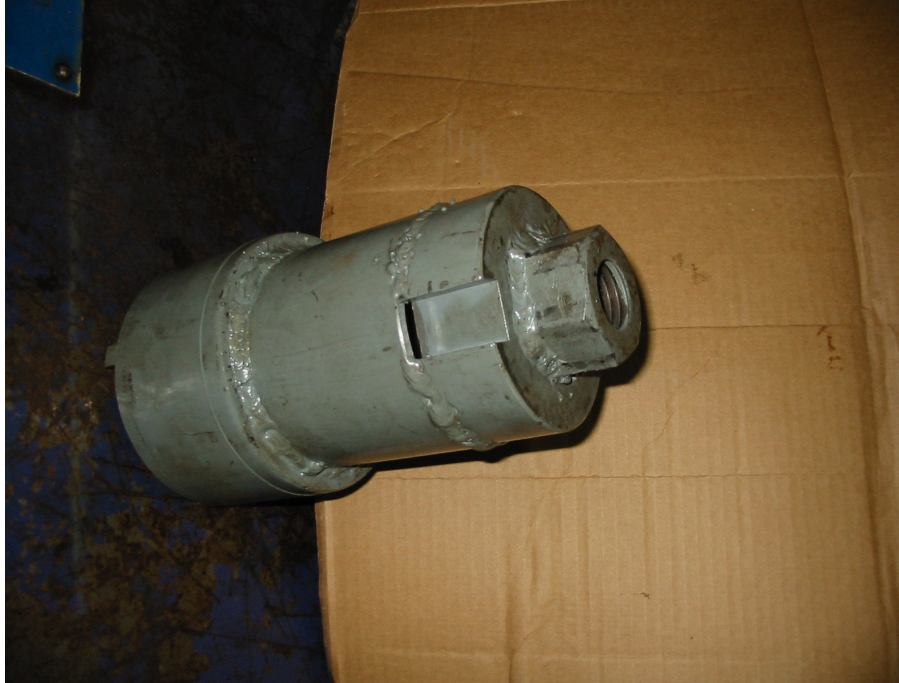
It was impossible to get a spanner wrench down into the gearbox case to take out the Timken nut. The Wizard said "no problem!!". He then made this tool to reach down inside the case and turn the nut off. Note one of the square tangs on the bottom left used to engage the square notches on the side of the bearing nut. Note the 1 1/4 inch diameter nut welded to the top of the tool, to turn it with a socket.

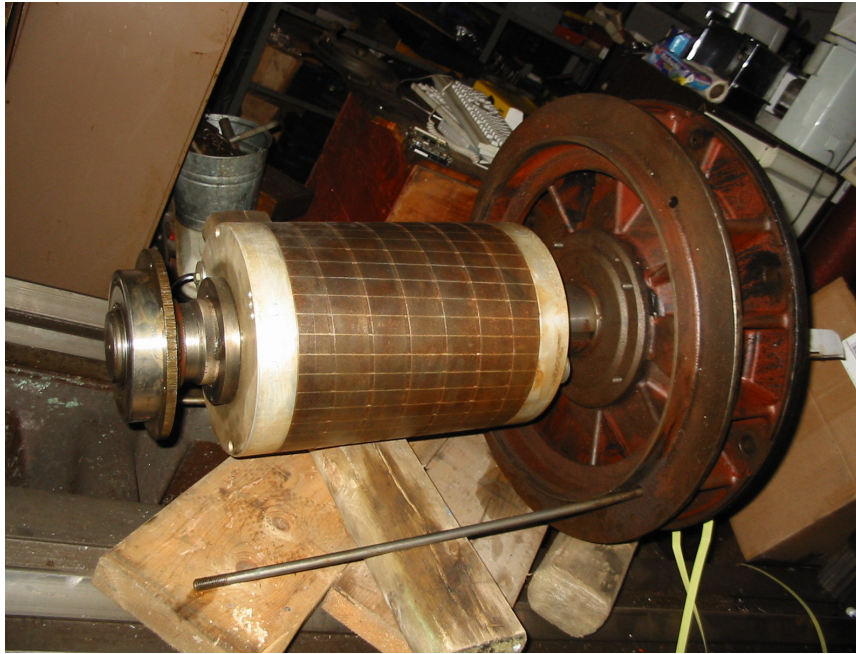
A view of the generator rotor. We replaced both end bearings. The inboard bearing is an FAG-6317-2ZRC. The outboard bearing is an SKF-6314-2Z/C3.

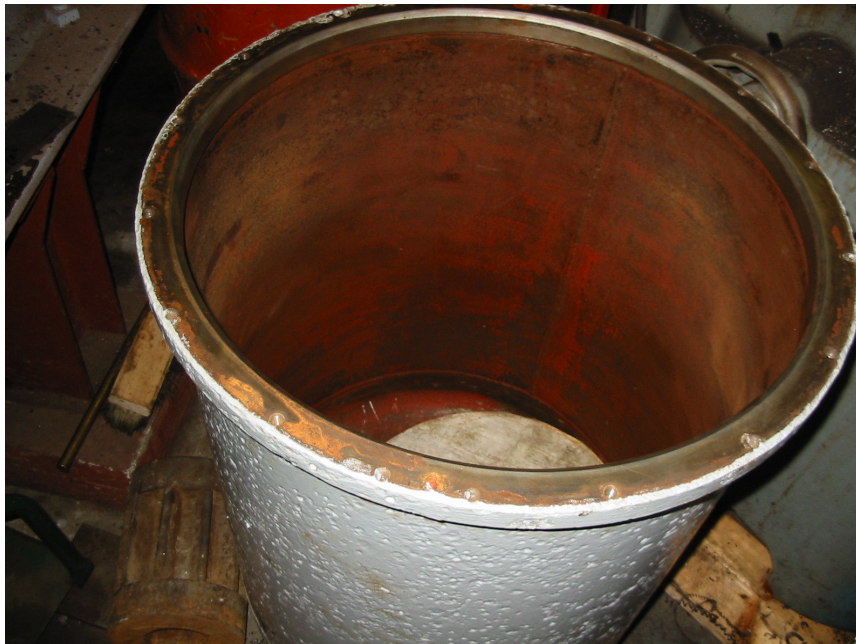
This is the heavy steel tank that houses the generator. It has been sandblasted and painted. Note the heavy corrosive pitting on its outside surface.

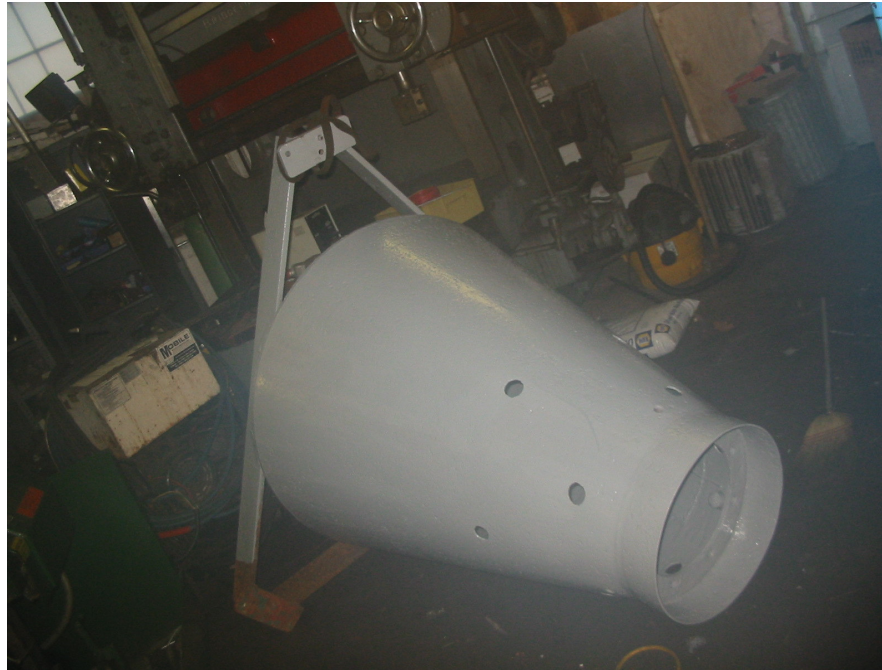
This is the inner cone. The generator/speed increaser assembly fits inside this cone. After the water flows through the propellor, it discharges through an annular draft tube. The annulus is formed by the outside of this cone and the inside of the larger, outer cone. Note the ten 2 inch diameter, torch cut holes in the surface. We think some one was trying to tighten a hydraulic fitting and cut the holes in order to find the fitting. They are allowing the vacuum on the downstream side of the runner to escape. We put heavy card board on the inside of each hole, traced the individual outline and cut out a template. We flame cut the rough outline of the plug out of 3/8 inch trashrack stock. We pasted the cardboard template on the rough piece and used the large bench grinder to trim the piece to an exact fit. We then welded all the pieces in place.
